Nusa Islands Restoration Site

Blue Corner Marine Research
Andrew C.F. Taylor

Nusa Penida Restoration Project

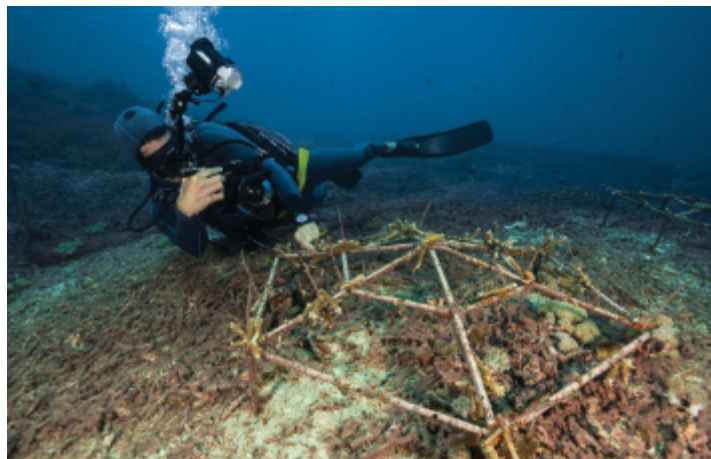
Large areas of broken and dead coral rubble have formed on the reef flat and reef crest along the northern coastline of Nusa Penida. As seen in many areas of SE Asia, when reef areas turn to rubble they are rarely able to recover naturally back into a functioning coral reef. The areas in Nusa Penida have not shown signs of recovery in at least 8-10 years which they have been observed. Rubble areas have actually been increasing in size due to erosion in currents and smothering of adjacent and down-slope reef area.

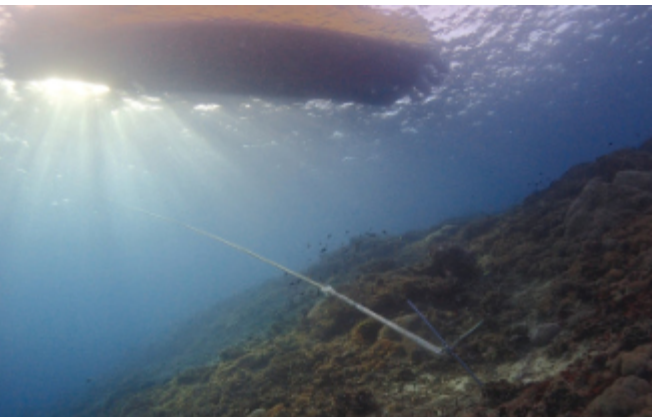
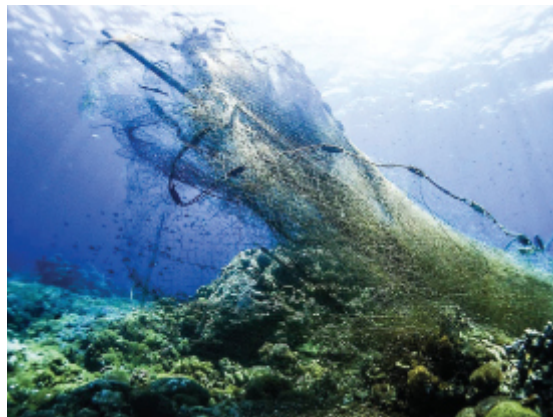
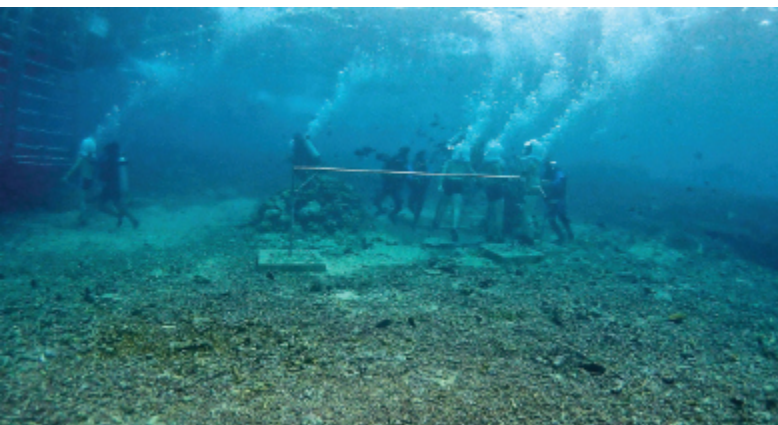
The resulting rubble areas are highly mobile and are showing signs of eroding down the reef slope increasing the size of the impact footprint. Little recruitment survival are seen in rubble areas. There is reduced reef health compared to adjacent reef areas, due to the impact site being 100% rubble.

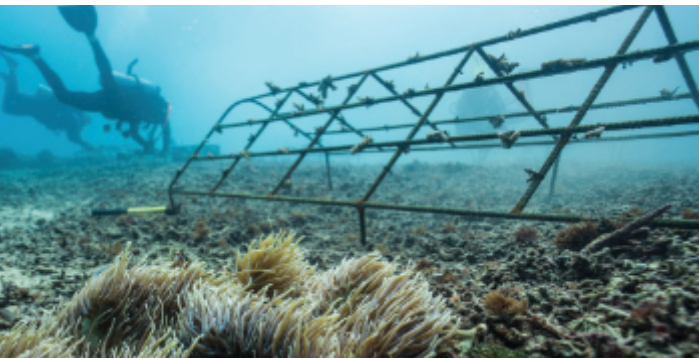
We designed modular metal frames and covered them in a non-toxic calcium carbonate coating (epoxy & sand). Rebar frames are coated to prevent premature metal degradation and to promote coralline algae settlement and coral attachment. The frames provide topographical structure to the reef and are used as building blocks for habitat formation. They also provide a stable substrate for coral transplantation.

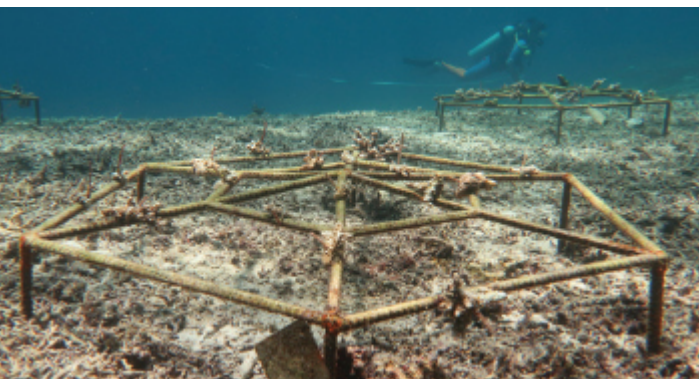
Structures were deployed onto the restoration site in a formation along the natural reef crest and clustered in other high erosion areas within the reef flat and slope. This formation had two physical restoration purposes - firstly to trap rubble from shifting down the reef slope and eroding into healthy reef areas; and secondly to reduce onshore wave energy. Biological rationale to the design was to provide

patch-reefs in which herbivorous fish and invertebrates could easily colonize by immigrating from adjacent reef area.

Additional factors influencing structure design was ease of installation and cost effectiveness. Structures were transported to the restoration site and installed by volunteers. The site is in a high current area at the terminus of the Indonesian-Through-Flow ocean current. Therefore the structural restoration techniques required needed to be designed to handle strong forces from high water currents.

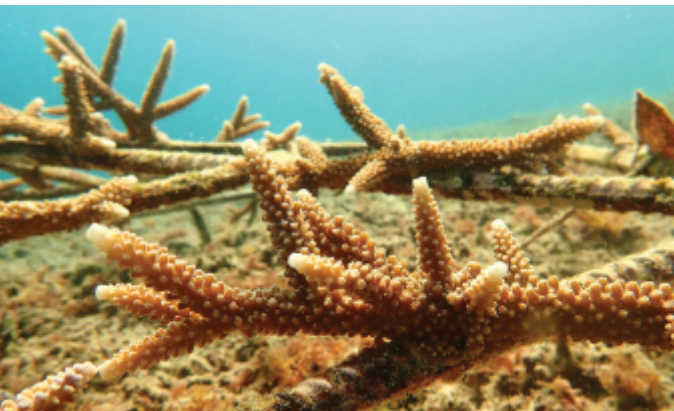
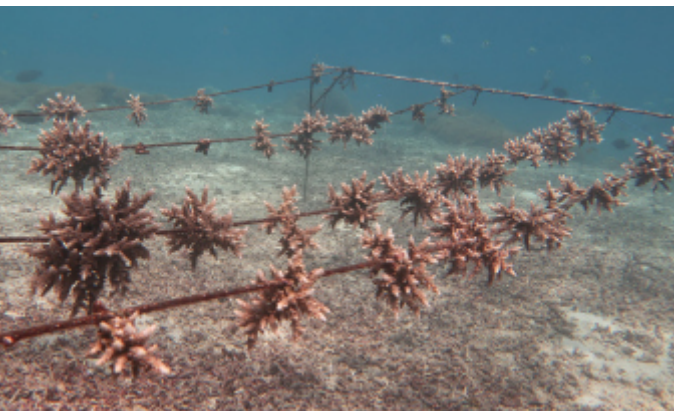
species were utilized for the initial biological restoration efforts.

We chose to focus on the dominant species growing in adjacent areas at similar depths and environmental conditions. As well as some of the quick growing habitat forming species such as *Acroporas*.

After structural restoration was started, we began transplanting coral fragments into the area. Three species of *Acropora* corals were transplanted as these pioneering species are known to grow quickly to aid in substrate stabilization and provide refuge for natural settlement of coral larvae. Transplants were sourced from an area within the same 1km area and environmental conditions, so as to not introduce new genetic stock or species. In an attempt to kick-start recovery and successional coral communities we transplanted several more species in order to more accurately reflect the community composition of

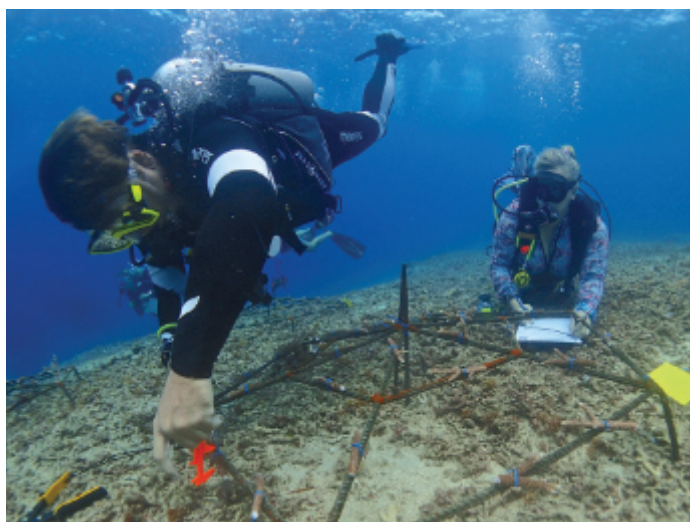
We are monitoring the restoration site in comparison to adjacent reference sites of both healthy and un-restored impacted reef. Regular monitoring is conducted on the site to look at:

- transplant growth. Measurements of linear extension on coral transplants are made at regular intervals.
- transplant survivorship;
- Coral coverage. Photographs of each frame show percent cover coral increase.
- coral health.
- if the transplanted corals will begin sexually reproducing in the next spawning season. Transplants were taken from multiple parents so that the restoration plan included genetic diversity of corals.

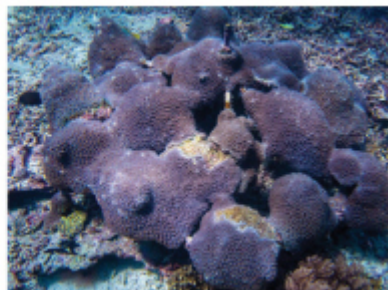
Galaxea transplants

The massive coral *Galaxea* appears to survive well at the restoration site however is slow to accrete onto metal frames. We adapted the

Growth progression from Dec 2018 to June 2021 (2.5 years)

structure design in later phases of the project to create frames covered with a metal mesh for encrusting and massive coral species. This adapt-

ed structure design seems to be more effective in allowing those coral growth forms to attach.

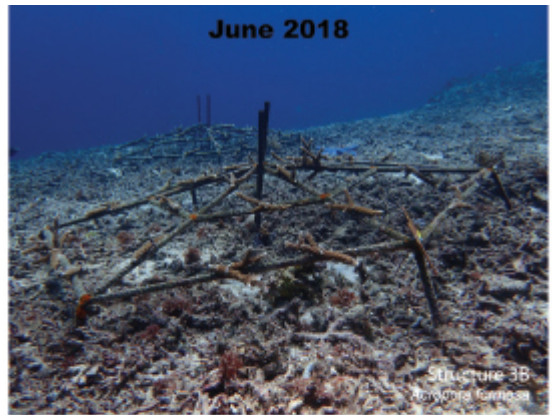
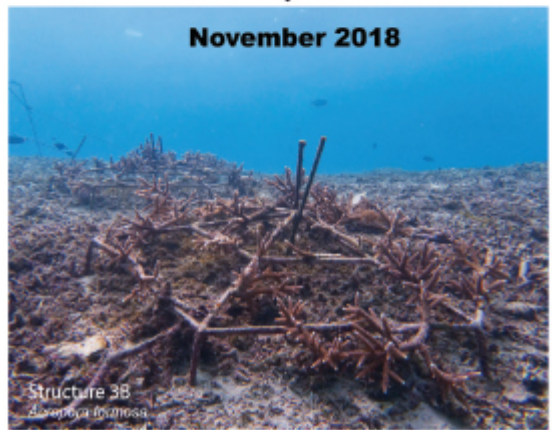
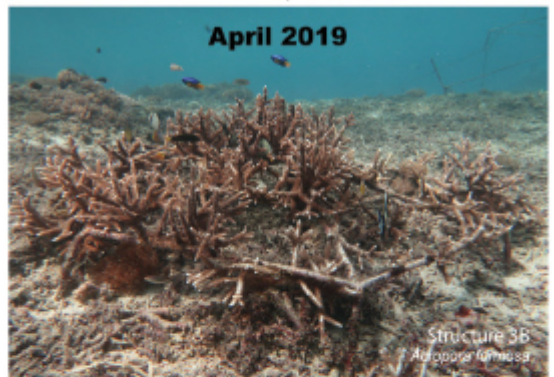
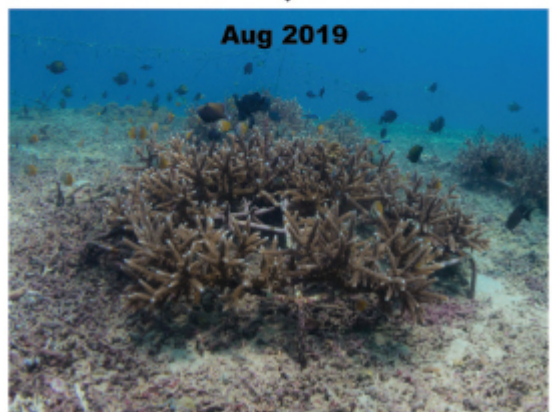
We experimented with frames hosting only a single species of transplants versus frames

with multiple species. Restoration projects in other locations have found that planting multiple species of coral together in clusters is more effective for growth and survivalship. However in our project we have found the opposite of that effect - our frames with single species transplants had higher growth and transplant survival rates than those frames with multiple species! An interesting thing to note was also that frames with multiple species transplants had a greater amount of settlement from other reef organisms such as hydroids, sponges, algae & soft corals.

We have found that coral transplants growing in single-species clusters are showing higher growth rates rather than when planted in mixed-species clusters, for the initial year

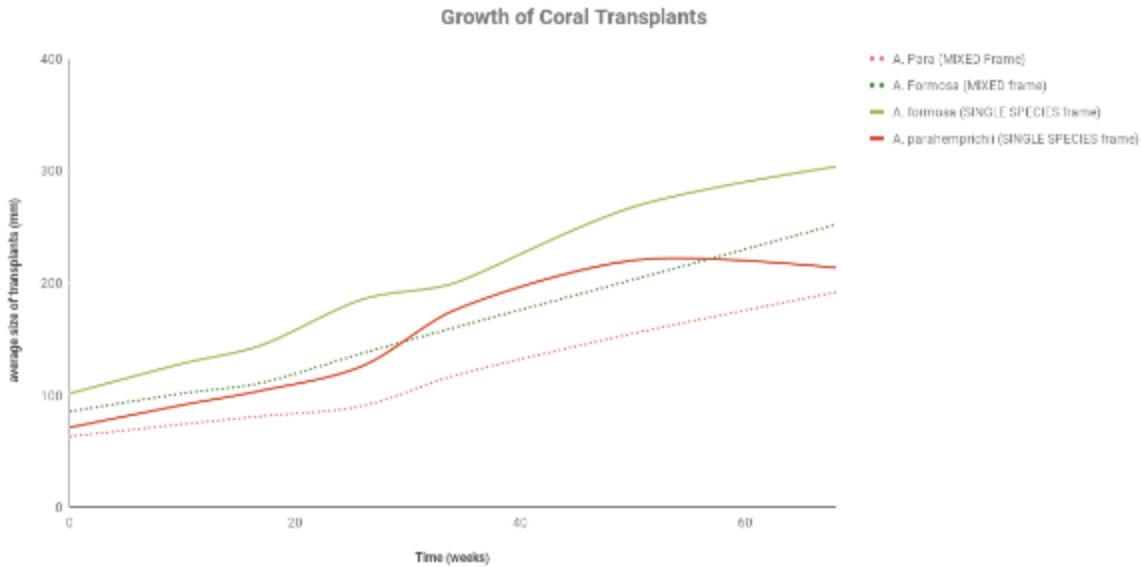
Growth Rates of Coral

Transplants:

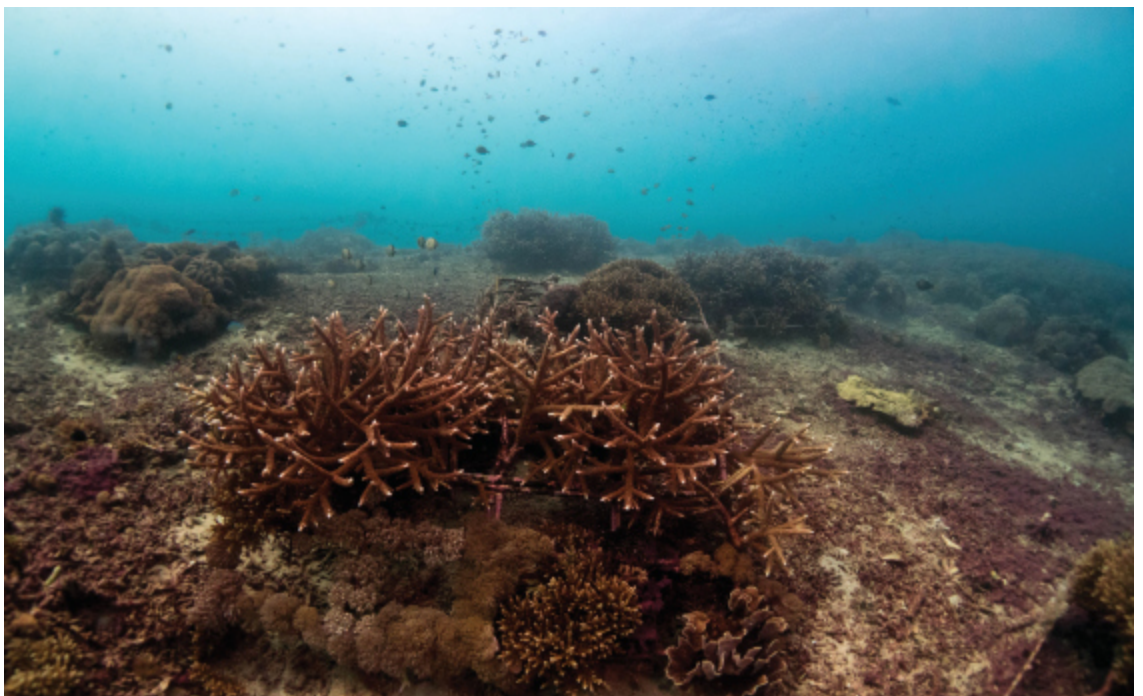
Substrate Composition at Restoration Site

Monitoring efforts at the restoration site have included conducting Reef Check surveys. A component of these surveys is point-intercept transects which measure percent coverage of various substrates. Results from monitoring studies have shown increasing coverage of hard corals, while proportionately decreasing amount of rubble substrate.

Coverage of hard coral at the restoration site has gradually been increasing, while stabilization methods have also appeared to be working effectively at reducing the coverage of rubble.
